Detailed Structural Audit Report of Kendriya Vidyalaya No.3

With reference to the letter No.F.1106/1-2/KV-3/Gwl/Technical Audit/410 dated on 16 August, 2021, committee visited Kendriya Vidyalaya No.03 situated at Morar Cantt., Gwalior to carry out the structural audit of the structure. Details of the Structural audit are collected in the Performa. Structure is G + 1 and the type of structure is reinforced concrete framed structure. Committee has physically verified the structure and rebound hammer testing was done at least 10% of the total columns, beams & slabs available in the structure. On the basis of the observations, following is recommended.

STRUCTURAL AUDIT REPORT

Name of the Building: Kendriya Vidyalaya No.03

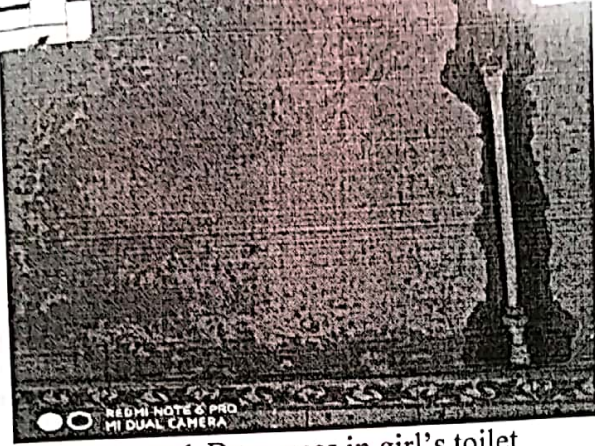
Photo 1: Dampness in girl's toilet

- Dampness and spalling of concrete are observed in boy's toilet & girl's toilet of ground floor near to chemistry laboratory. It is recommended to provide adequate water proofing at the terrace. It is also observed that reinforced is visible and is corroded. Following steps are recommended:
For inspection, it is necessary to expose the corroded locations up to such an extent that these locations can be seen through naked eye. First step in treatment of rusting on reinforcement is cleaning of rust with the wire brush. After cleaning, tamp the surface with hammer having the weight at least 5 lbs. Then rub the surface with wire brush or hessian rope. In the market, many rust removing chemicals are also available. Those chemicals can be used if cleaning of rust is to be done more effectively. In important members (members that has to carry heavy load) of RC structures, sand blasting can be used for cleaning of rust. If the cleaned surface is found heavily corroded, then the surface can be coated with black ship paint (that paint is marine paint). This paint usually seals off the steel surface and prevents the further corrosion. Corroded members which are critical in the whole structure such as columns should be additionally reinforced by using hooked or anchorage connections or by using beams. Corroded slabs can be additionally reinforced by using wire mesh (which is locally said to be as Jali).

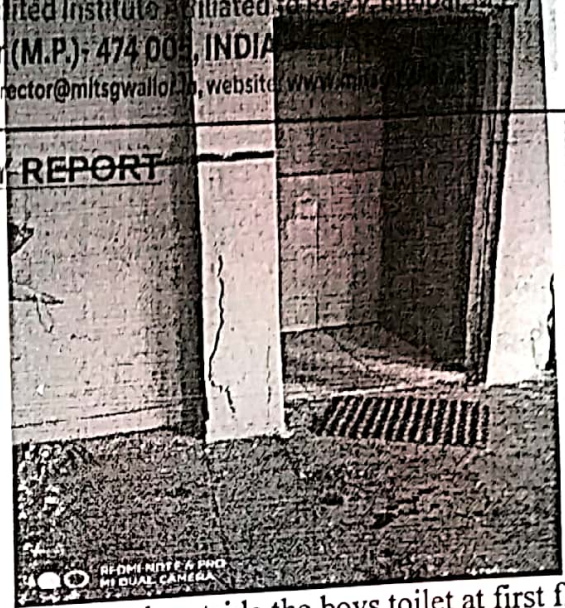
Photo 2: Crack outside the boys toilet at first floor

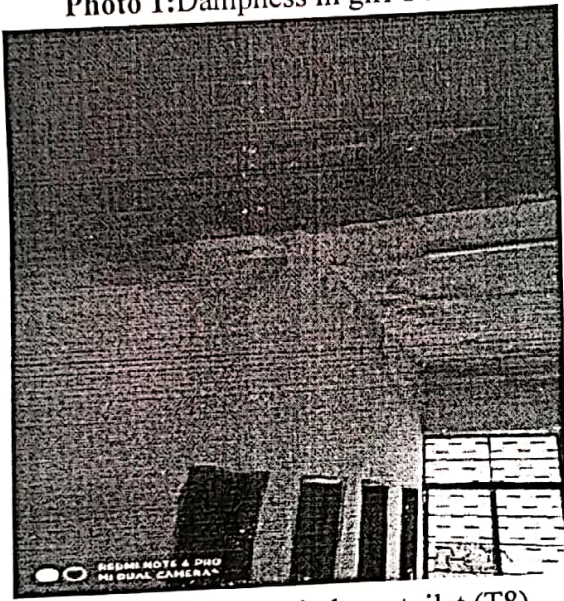
Photo 3: Dampness in boys toilet (T8)

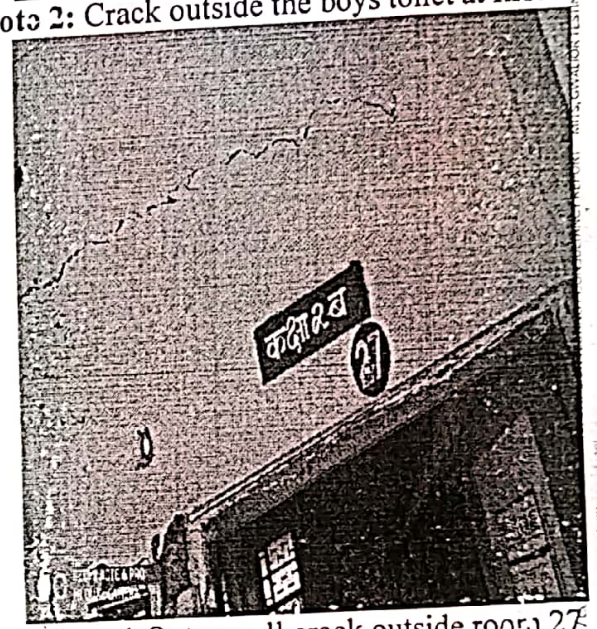
Photo 4: Outer wall crack outside room 27

- Large crack has been observed in the wall of room no. 10. It is recommended for proper filling and sealing of crack should be performed.
- Diagonal crack has been observed on inside and outside wall of the conference hall, room no. 4, room no. 27, due to seismic activity in the near past. So, proper filling and sealing of the crack has to be performed.

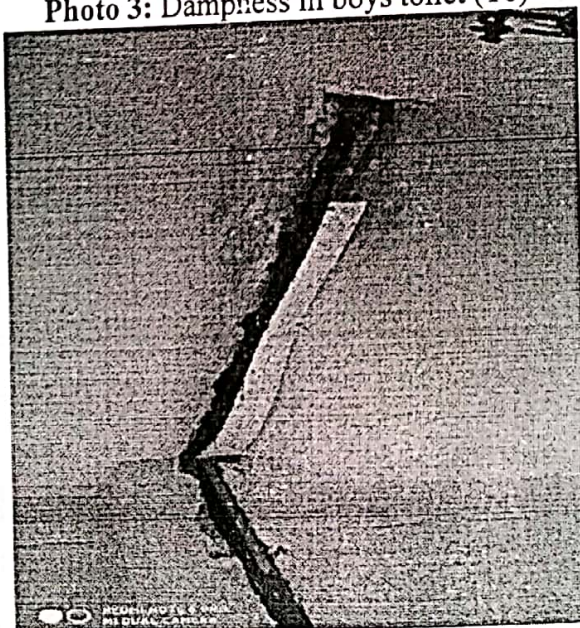
Photo 5: Open joint between wall and plinth beam near

Room 23

- Joint between the wall and the plinth beam has been observed in room no. 23. It is recommended to assess the depth of the cracks and seal the joints effectively.

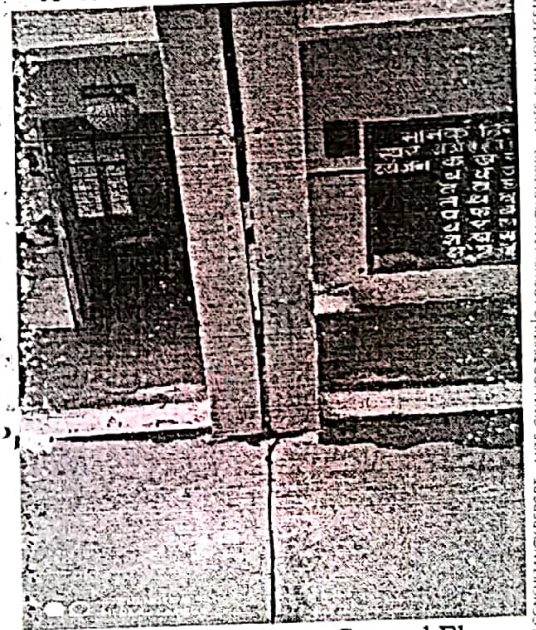
Photo 6: Open joint at Ground Floor

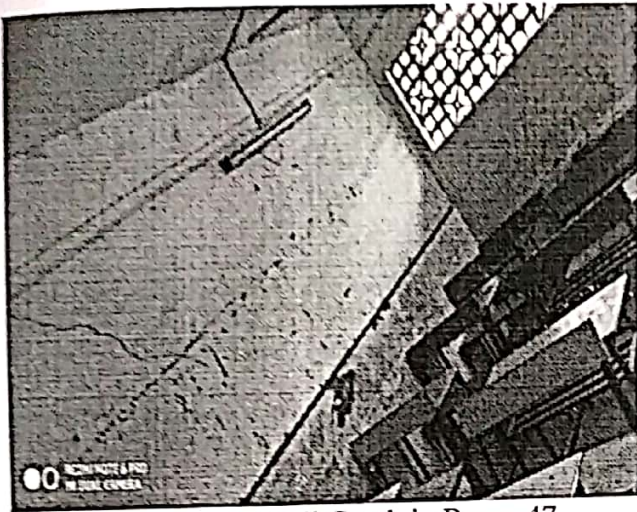
Photo 7: Big Wall Crack in Room 47

- Large cracks in the tie beam and wall has been observed in room no. 47. Proper filling and sealing of cracks has to be performed.
 - Inner and outer wall cracks have been observed near to room no. 45. Similarly, outer wall cracks have been observed in room no. 46. Proper filling and sealing of cracks has to be performed.

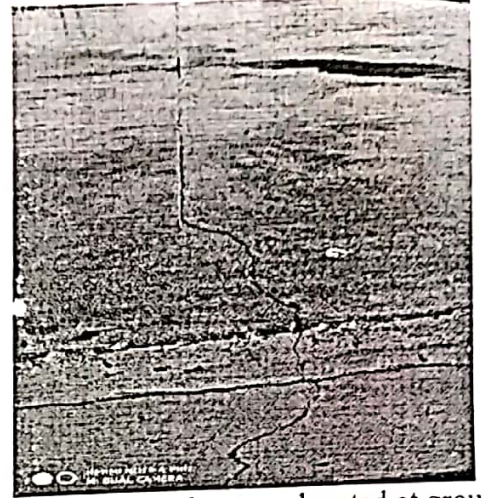
Photo 8: Cracking on the stage located at ground floor

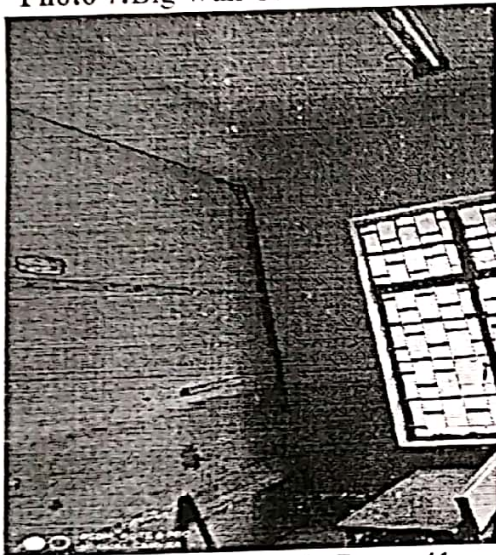
Photo 9: Open joint in Room 41

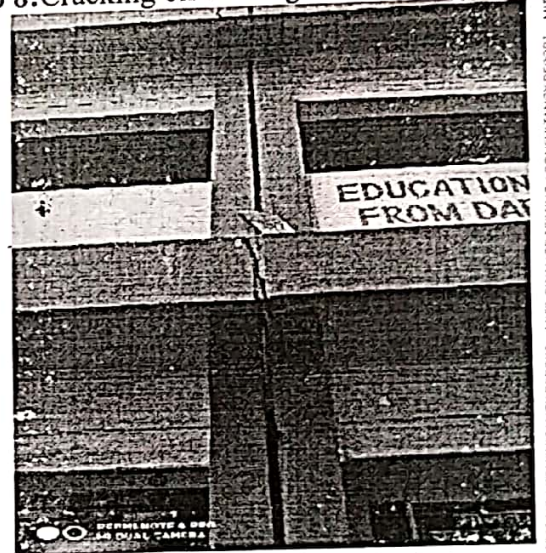
Photo 10: Open joint adjoining Room 23

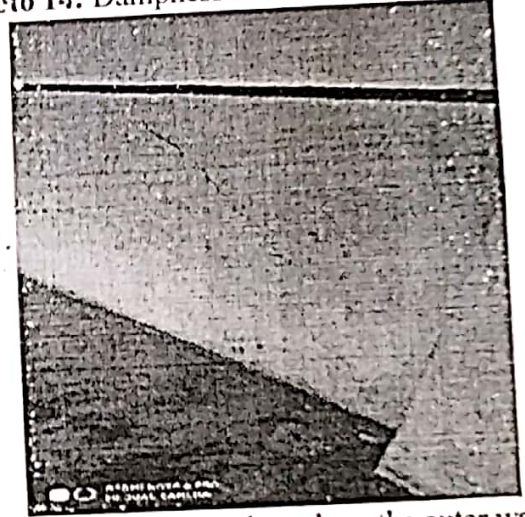
Photo 15: Crack on the outer wall adjoining the water tank and deterioration in the support of the water tank

- Cracks in the plaster have been observed at the base of water tank. It is recommended to remove the cracked plaster and replace it with new plaster with epoxy coating.

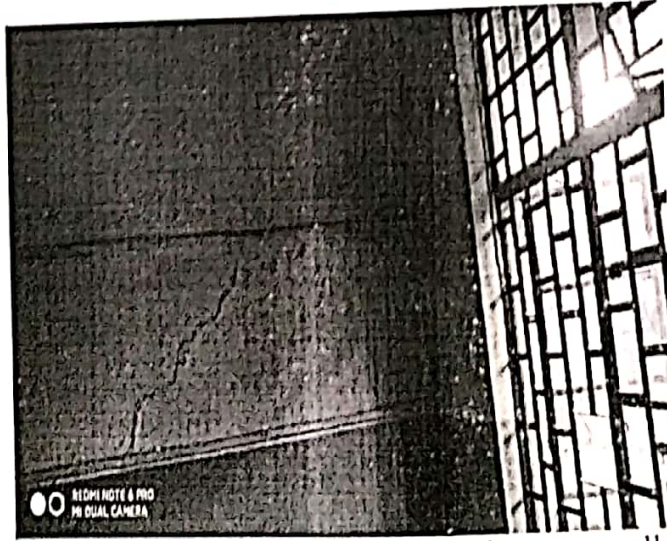
Photo 16: Diagonal crack on the outer wall

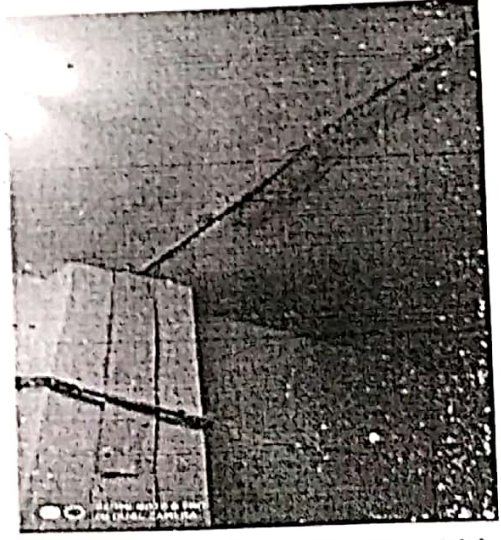
Photo 17: Diagonal cracking on the classroom wall
Book No.: MITS TCR/ XXIV

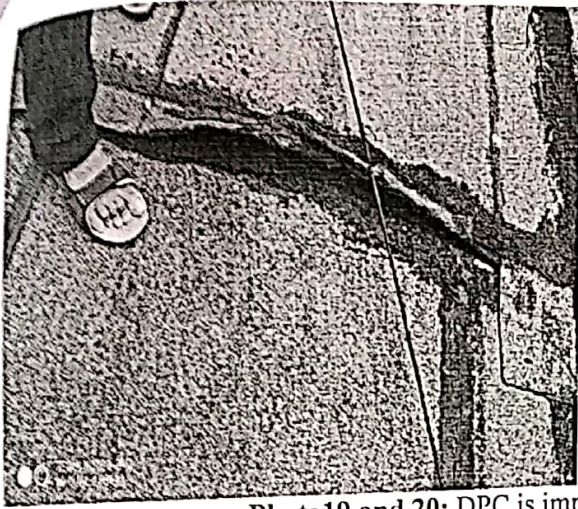
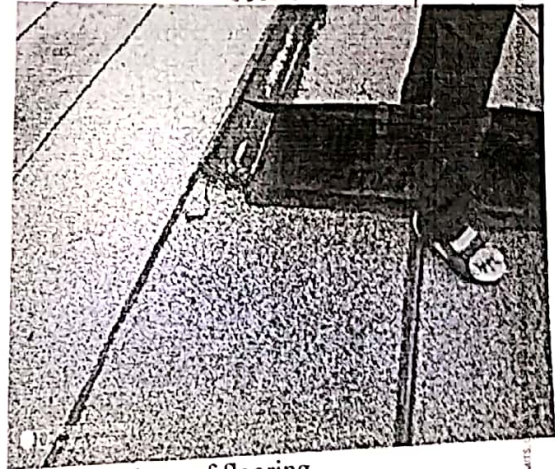
Photo19 and 20: DPC is improperly attached to the roof flooring

- Cracks at the bottom face of the slab in the gallery near to boy's toilet (T-9). Proper filling and sealing of cracks has to be performed.
 - Damp proof course has been provided in 2015. It has been observed that in the damp proof course the joints are not properly sealed. As a result, dampness and seepage is seen in the first and ground floor level. It is recommended to seal the joints of the terrace slab and then provide adequate damp proof course with proper sealing of joints.

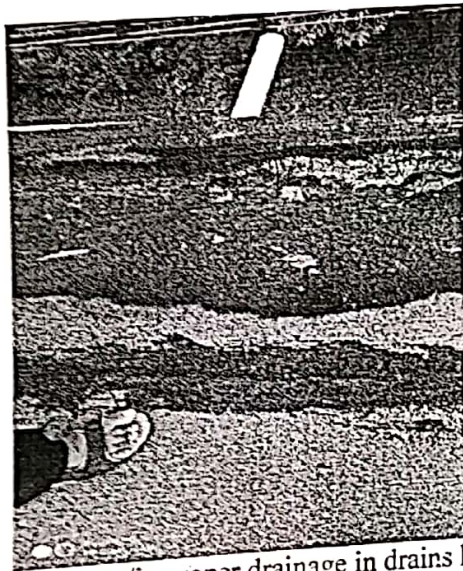
Photo 21: Blockage/improper drainage in drains located

- Improper drainage has been observed at the terrace. It is recommended to provide adequate drainage with properly maintaining the slopes towards the drains. Also, it has been seen that existing drainage openings are either small or clogged. It is recommended to properly unclog the drains.

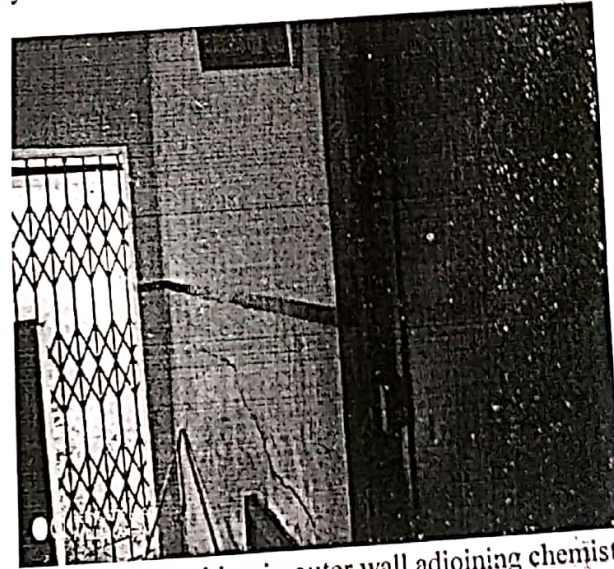
Photo 22: Cracking in outer wall adjoining chemist lab

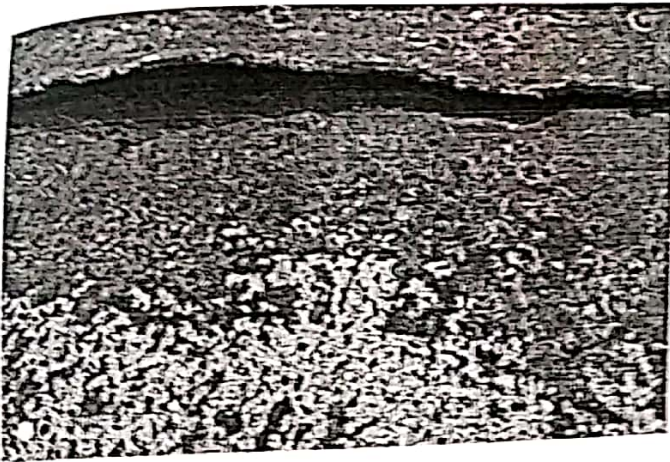
Photo 23: Break/tear in DPC on the roof

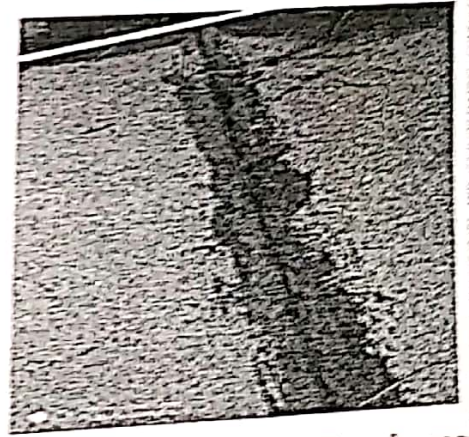
Photo 24: Break/tear in DPC on the roof

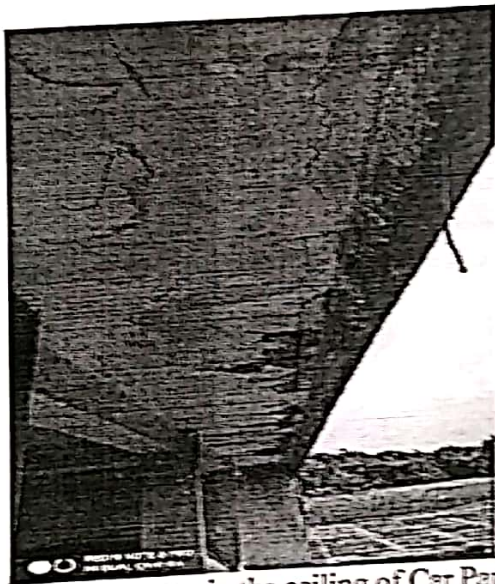
Photo 25: Dampness in the ceiling of Car Parking

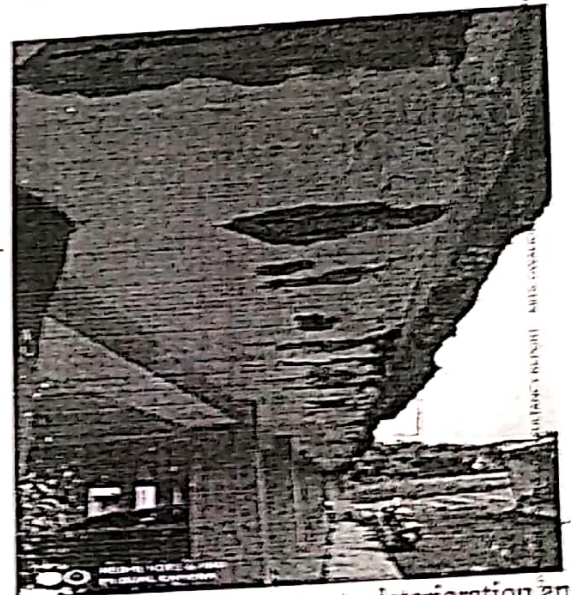
Photo 26: Excessive concrete deterioration and reinforcement exposure in the ceiling of car parki

- Reinforcement of the roof slab of parking lot is corroded and concrete is continuously spalling. It is recommended to remove the cracked concrete and along with the retrofitting action of corroded concrete new rebars to be attached and welded for better serviceability and durability of the structure.

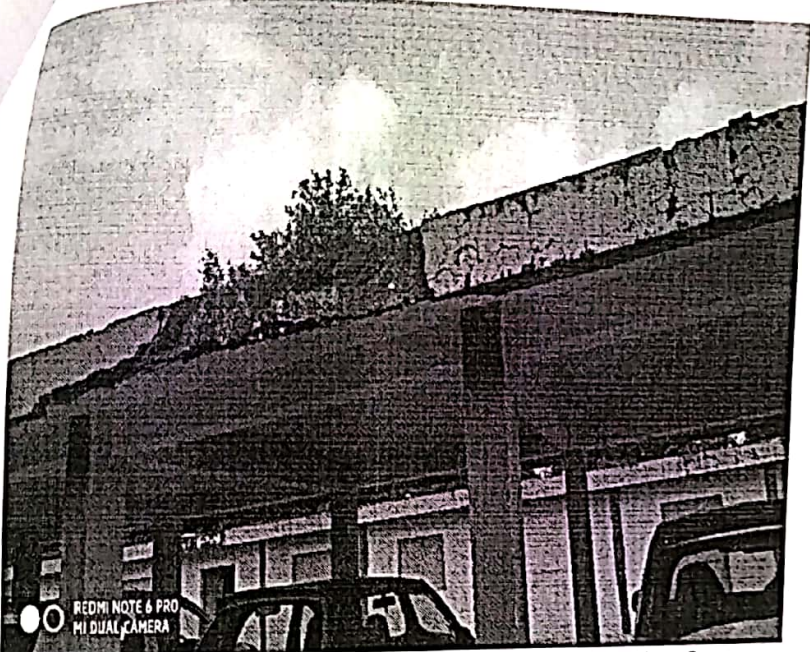
Photo 27: Spalling of concrete in the roof slab of car parking

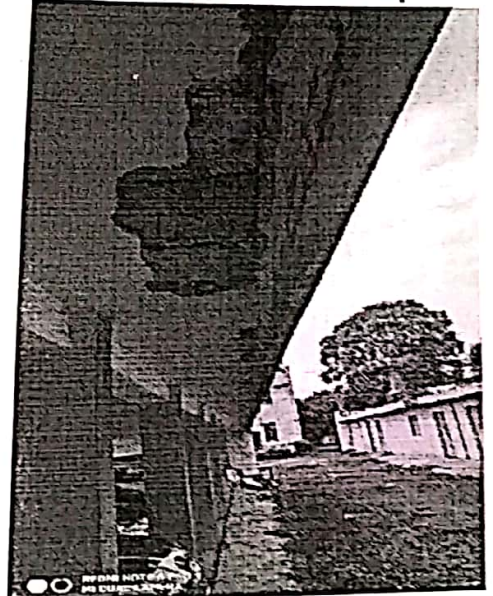
Photo 28: Spalling of concrete and exposure of reinforcement in the ceiling of car parking
