Detailed Structural Audit Report of Kendriya Vidyalaya No.3

With reference to the letter No.F.1106/1-2/KV-3/Gwl/Technical Audit/410 dated on 16 August, 2021, committee visited Kendriya Vidyalaya No.03 situated at Morar Cantt., Gwalior to carry out the structural audit of the structure. Details of the Structural audit are collected in the Performa. Structure is G + 1 and the type of structure is reinforced concrete framed structure. Committee has physically verified the structure and rebound hammer testing was done at least 10% of the total columns, beams & slabs available in the structure. On the basis of the observations, following is recommended.

STRUCTURAL AUDIT REPORT

Name of the Building: Kendriya Vidyalaya No.03

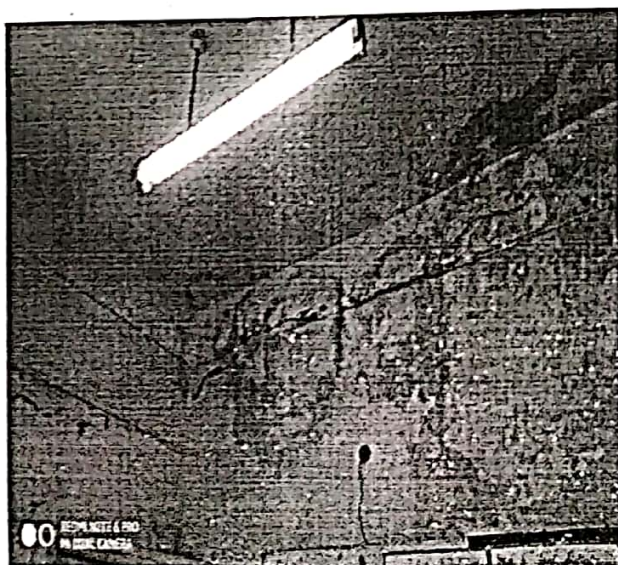
Photo 10: Open joint adjoining Room 23

- Joint between the wall and the plinth beam has been observed in room no. 23. It is recommended to assess the depth of the cracks and seal the joints effectively.
